# Full Scale Testing of FRP Repaired Prestressed Beams

# The Ghost Girders

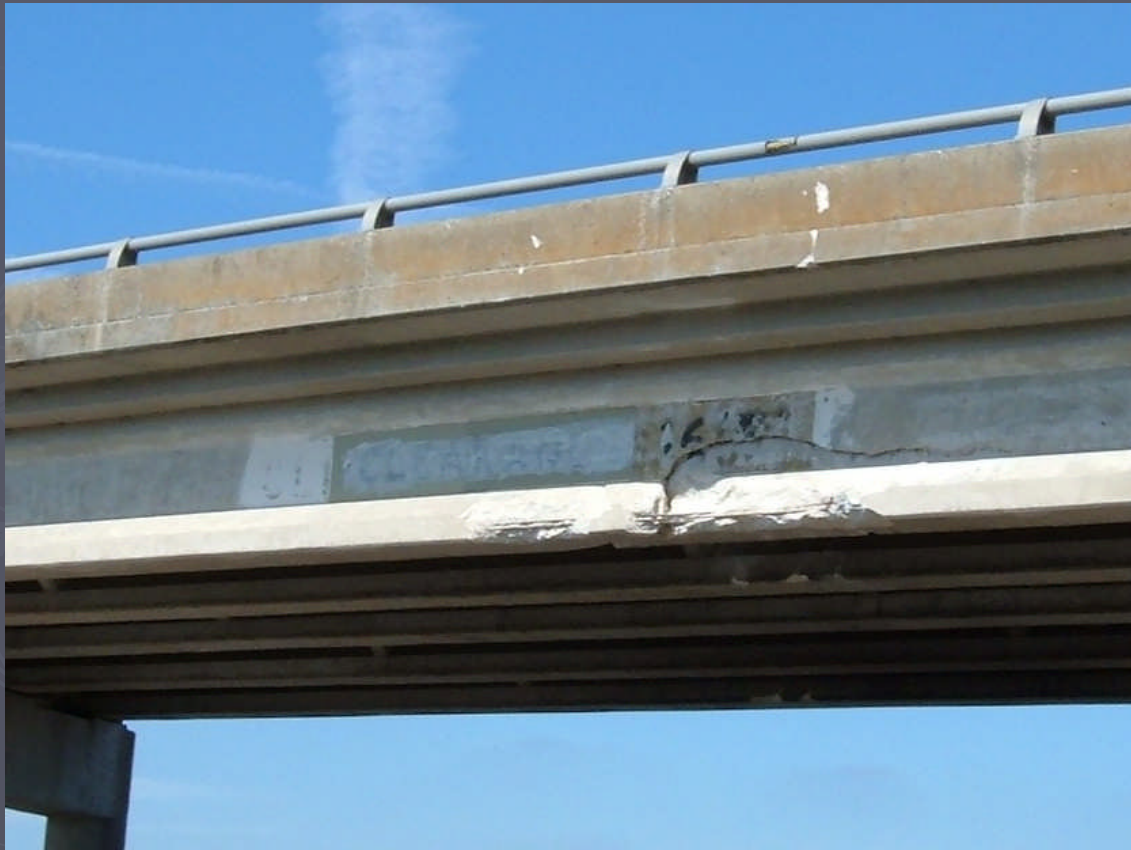
Beams were artificially damaged to simulate what happens in the field due to impact with over height vehicles
