Nuclear Engineering and Design 156 (1995) 269–276

Dynamic and static collapse tests of reinforced-concrete columns

The reinforced-concrete column damage pattern differences between static cyclic loading tests and dynamic shaking-table tests were observed. In this study, the spacings of shear reinforcement bars in columns were variable. Four types of shear reinforcement bar spacing are used. As a result of the tests, it was verified that the maximum horizontal strengths of columns, the deformation capacities and the damage patterns were changed with the shear reinforcement bar spacings, and also with testing method differences between statics and dynamics. Furthermore, $P-\delta$ effects were discussed.

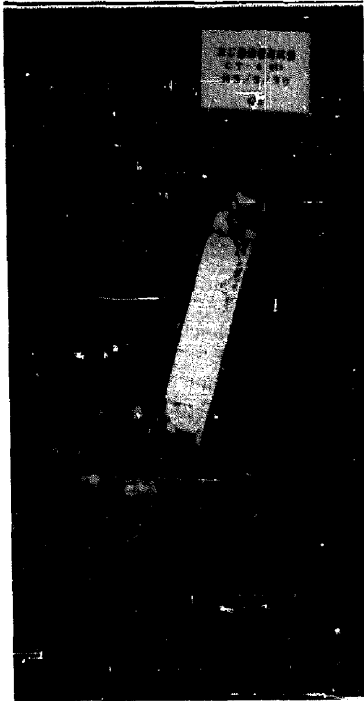
Fig. 4. 50 mm static loading test damage.

column ends on cyclic loading with a deformation angle of $1/100$. With a cyclic loading of $1/50$, the shear cracks increased diagonally, and the main steel bars of the two columns in X-1 frame buckled at the midheight, with separation of concrete and main steel bars; the roof fell down at last. In the static cyclic loading test with columns of reinforcement bar spacing 50 mm, the bending cracks concentrated in the region from the two column ends up to 10 or 20 cm positions with cyclic loadings of $1/50$ and $1/25$. With a cyclic loading of $1/5$, the compressive crushes of two column ends began immediately. Finally, the concrete of the two column ends was crushed completely, and the main steel bars buckled. The crack sketches of these loadings are shown in Figs. 4 and 5. The load-displacement hysteresis loops of these two static cyclic loading tests are shown in Figs. 6 and 7.

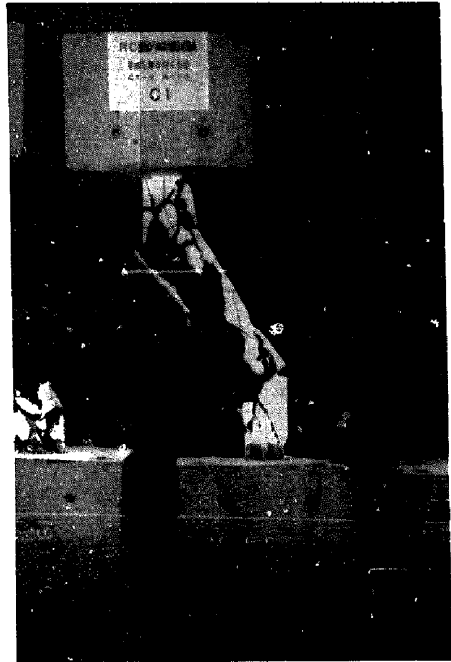
Fig. 10. 170 mm dynamic test damage.

In the test with a reinforcement bar spacing of 170 mm, the initial crack types were the same as in the 285 mm test case. However, the columns collapsed during the next opposite acceleration with the separation of concrete and steel bars, and with the crushing of core concrete.

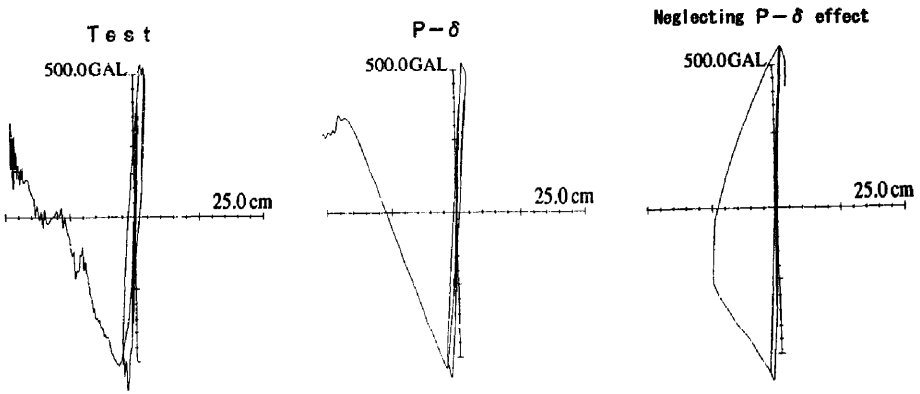
Fig. 13. 105 mm acceleration-storey displacement loop.

Four kinds of column were tested on the shaking table. The natural frequency of the elastic regions of each test structure was 4.5 Hz approximately. The damping ratios in the elastic regions were estimated to be about 5% by AR model analysis. No distinct differences between the four test structures were found. The plastic region dominant frequencies of each test structure were about 3 Hz at the time just before collapse. The four test structures collapsed at the beginning of the main shocks. The damaged columns are shown in Figs. 8–11. Acceleration–storey displacement hysteresis loops of the four shaking table tests are shown in Figs. 12–15.

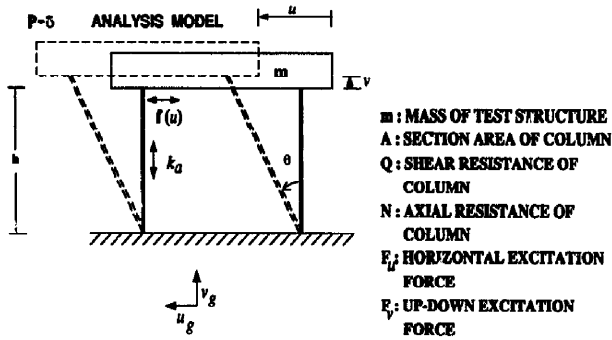
roof mass, i.e. $P-\delta$ effects. A simple model with rigid girders, shown in Fig. 16, is considered. The equations for this model (Minowa, 1985) are expressed as follows:

Fig. 16. *P*- δ analysis model.
