PACIFIC EARTHQUAKE ENGINEERING RESEARCH CENTER

Seismic Performance of an Instrumented Tilt-up Wall Building

PEER Report 2004/04
Pacific Earthquake Engineering Research Center
College of Engineering
University of California, Berkeley

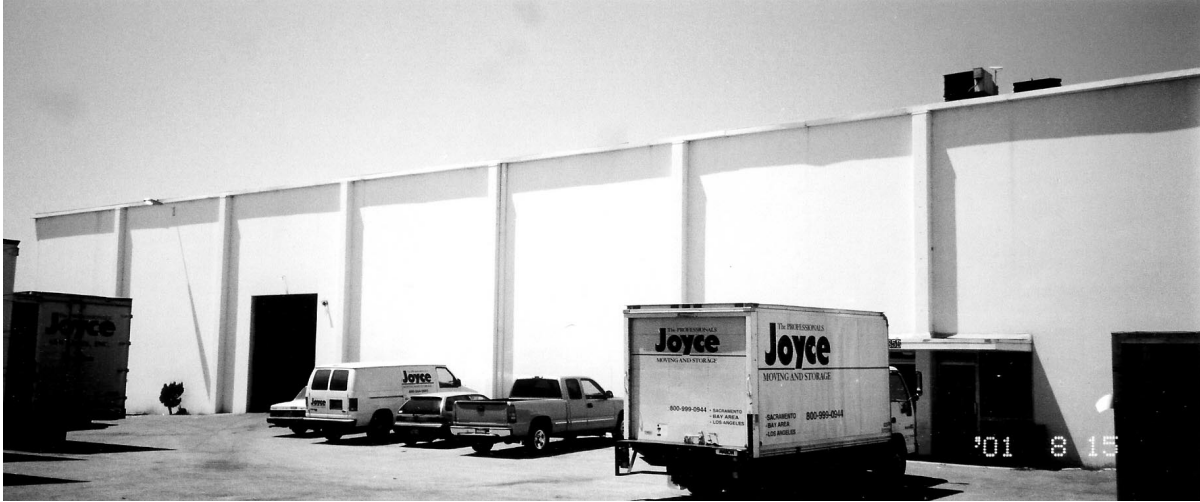
Fig. 2.1 View of tilt-up wall building looking west

The design of the tilt-up warehouse in Redlands, California, was completed in the fall of 1971 following the San Fernando earthquake in February. Most likely, it was designed for the lateral force provisions of the 1969 Building Code. Construction was completed the following year. The building plan is 232 feet by 90 feet with the longitudinal dimension oriented in the north-south direction. A view of the east side of the building showing the access door near the south end of the building and the office located near the center is presented in Figure 2.1. An isometric drawing of the building is shown in Figure 2.2. The building is divided into two sections by a bearing stud partition that is located 132 feet from the south end (100 feet from the north end) as shown in the plan view of the roof in Figure 2.3. Small offices are located on each side of this partition on the east side of the building. Also, the east side of the building contains two large overhead doors (12 feet by 14 feet), one in the south section and one in the north, as can be seen in the east elevation (Fig. 2.4). There are no openings in the tilt-up walls of the other three sides of the building.

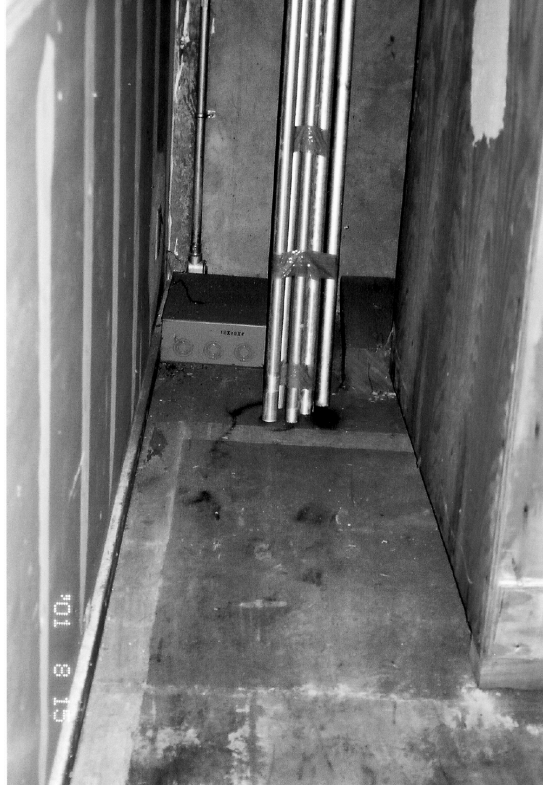
Fig. 3.2 Sensors 1, 11, 12 adjacent to fire wall

As part of the California Strong Motion Instrumentation Program (CSMIP), the building was instrumented with 12 strong motion accelerometers. The location of these instruments is shown in Figure 3.1. The installation of sensors 1, 11, and 12 on the floor slab is shown in Figure 3.2 to the right of the bearing stud partition. Sensor 2 is mounted at the midheight of the west wall just to the right of the partition (Fig. 3.3). Sensor 4 is mounted on the glulam beam at the partition and all other sensors are mounted on the walls just under the roof diaphragm. The instrumentation in this building, located almost midway between the San Jacinto and San Andreas fault systems, has recorded the response of the building to several earthquakes. Four of the strongest recorded ground motions were recorded during the following earthquakes: Palm Springs (July 8, 1986), Landers (June 28, 1992), Big Bear (June 28, 1992), and Northridge (January 17, 1994). The responses of the building under these ground motions are considered in this study. The site is 10 km (6.2 miles) miles from the epicenter of the Palm Springs earthquake, 74 km (46 miles) west of the epicenter of the Landers earthquake, 39 km (24 miles) west of the epicenter of the Big Bear earthquake, and 123 km (76 miles) southeast of the epicenter of the Northridge earthquake. Peak recorded accelerations in the building for these ground motions are summarized in Table 3.1 and corresponding displacements in Table 3.2.

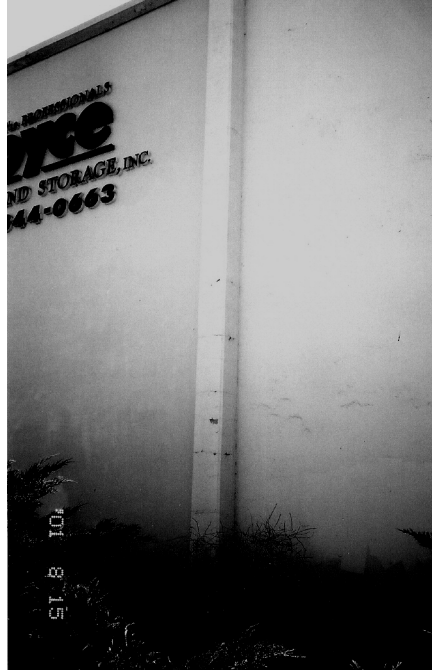
Fig. 4.1 Horizontal cracks in pilaster, north wall

It was noted that the degree of observed damage (cracking) (Figs. 4.1–4.2) had been more severe along the west and north walls than that observed along the east and south walls, respectively. This poses the question why? While structurally the north and south walls seem to be the same, there is a difference between the east and west walls. The main structural difference is their geometric configurations. The east wall has some significant openings that include two overhead doors for access to the warehouse, whereas, the west wall has no opening. Thus the in-plane stiffness of the west wall is higher than that of the east wall, and under the effects of the north-south components of the ground motions, the west wall in its elastic response will attract and develop higher inertial forces. This fact could be the reason for the development of some minor shear (diagonal) cracks in the west wall, as shown in Figure 4.2, and horizontal cracks in the pilasters of the north wall, as shown in Figure 4.3.

As illustrated in Figure 4.1, although a large number of small horizontal cracks occurred in the outside of the pilasters located in the north wall, similar cracks were not observed in the pilasters of the east wall. While there is no doubt that these cracks were a consequence of the flexural behavior of the pilasters, out of the plane of the wall, what was surprising at first sight is that such cracks were observed only at the outside of the pilasters of the west wall. To find the reasons for this particular pattern of damage, a series of simple analytical calculations were conducted based on different assumptions regarding the possible response of these longitudinal walls.

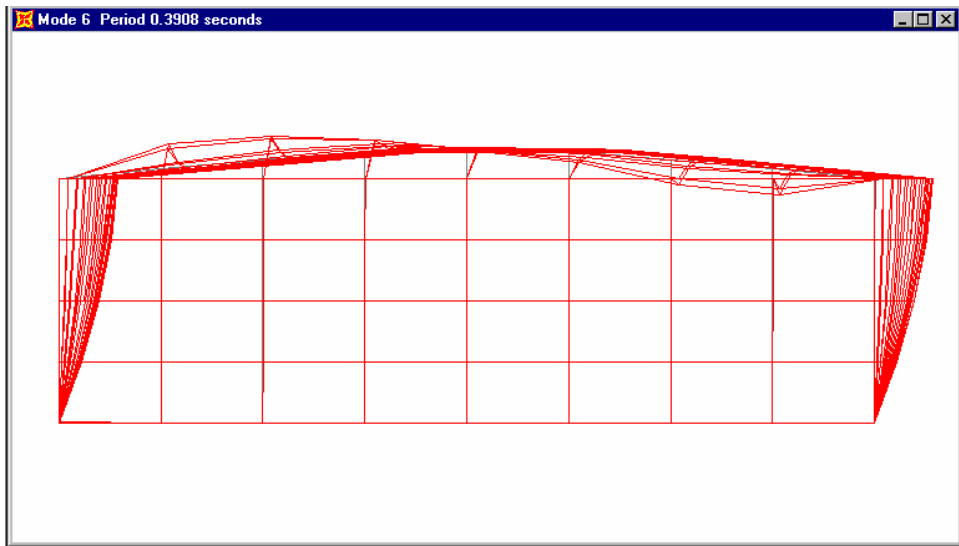
Fig. 6.2 Transverse fundamental mode shape

The deflected shape of the fundamental mode in the transverse (E-W) direction is shown in Figure 6.2, and the deflected shape of the fundamental mode in the longitudinal (N-S) direction in Figure 6.3. In this mode, the deformation of the roof diaphragm is large relative to the deformation of the walls, resulting in a somewhat distorted shape for the mode.
