Moehle, J.P., Eberhard, M.O. "Earthquake Damage to Bridges."
Bridge Engineering Handbook.
Ed. Wai-Fah Chen and Lian Duan
Boca Raton: CRC Press, 2000

Earthquake Damage to Bridges

Jack P. Moehle

Marc O. Eberhard

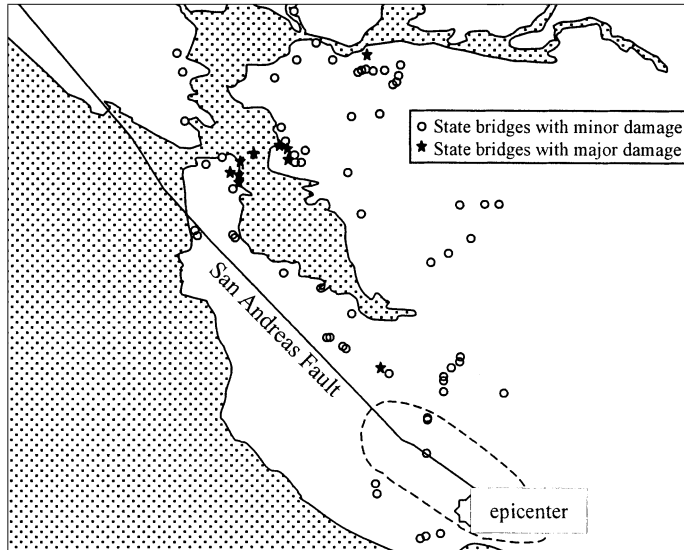
The influence of site conditions on bridge response became widely recognized following the 1989 Loma Prieta earthquake. [Figure 34.1](#) plots the locations of minor and major bridge damage from the Loma Prieta earthquake [16]. With some exceptions, the most significant damage occurred around the perimeter or within San Francisco Bay where relatively deep and soft soil deposits amplified the bedrock ground motion. In the same earthquake, the locations of collapse of the Cypress Street Viaduct nearly coincided with zones of natural and artificial fill where ground shaking was likely to have been the strongest ([Figure 34.2](#)) [10]. A major conclusion to be drawn from this and other earthquakes is the significant impact that local site conditions have on amplifying strong ground motion, and the subsequent increased vulnerability of bridges on soft soil sites. This observation is important because many bridges and elevated roadways traverse bodies of water where soft soil deposits are common.

FIGURE 34.1 Incidence of minor and major damage in the 1989 Loma Prieta earthquake [modified from Zelinski, 16].

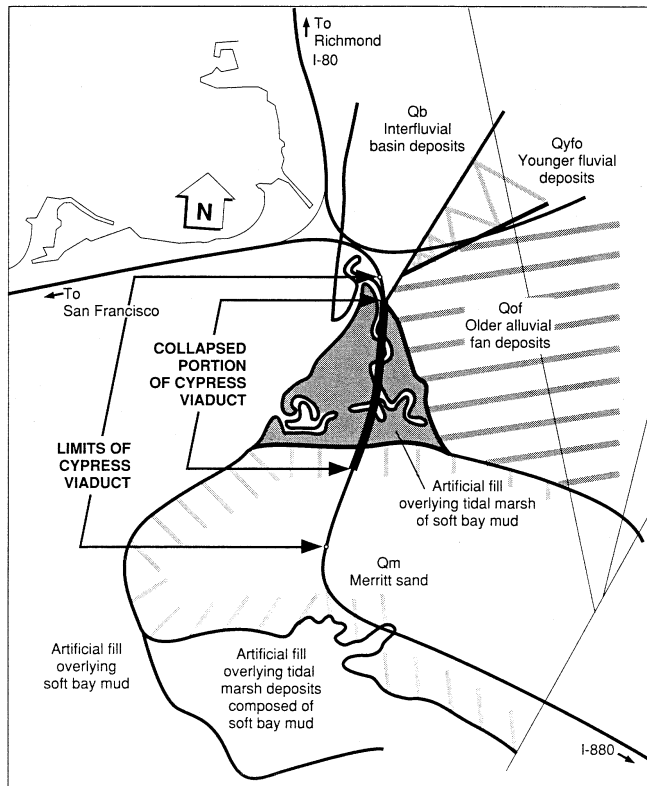
FIGURE 34.2 Geologic map of Cypress Street Viaduct site. (Source: Housner, G., Report to the Governor, Office of Planning and Research, State of California, 1990.)
